**Assessment of the Nordic Aquafarms Permit to Satisfy
Clean Water Act Requirements**

Testimony to the Maine DEP Water Supply and Dam Evaluation

Proposed Nordic Aquafarms, Belfast Maine

December 13, 2019
Project 1900162

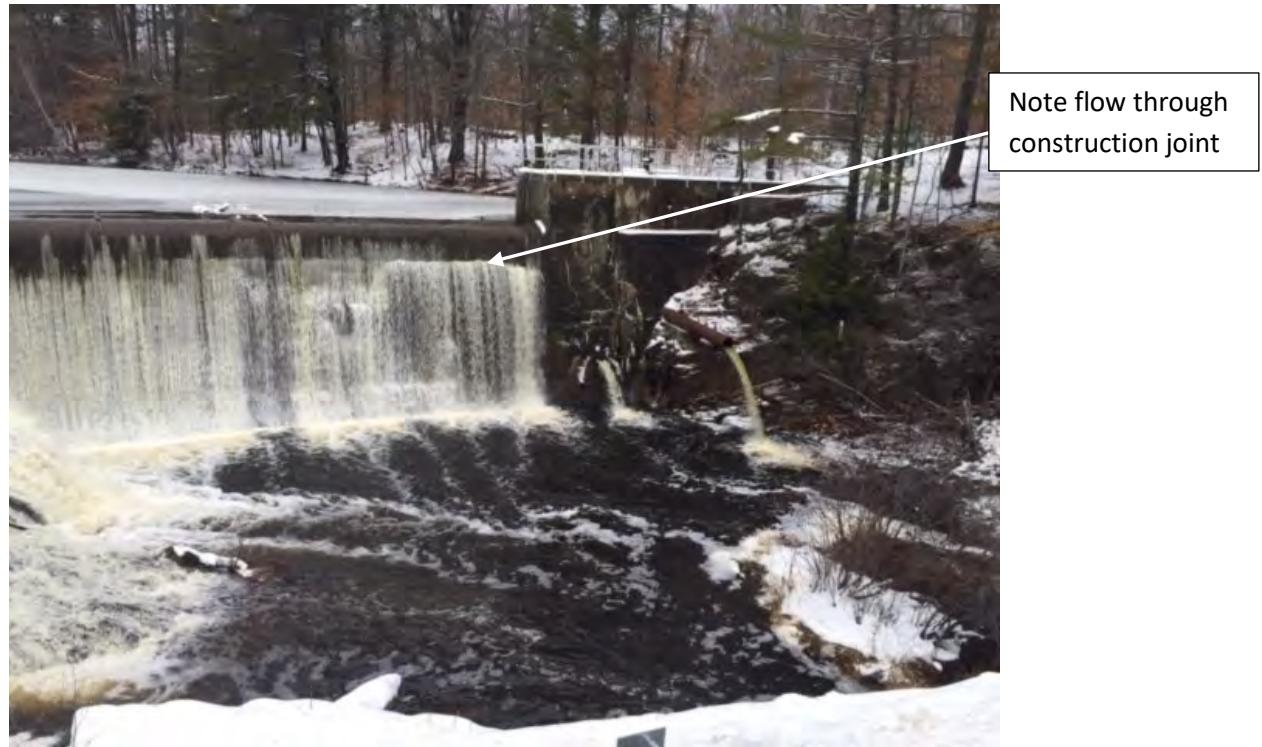
- 2017** Mr. Fred Johnson (GEI) visited Upper Dam on December 13 and observed water flowing over the top of the spillway sill (see Photos 1 and 2 in Appendix A).

Photo No. 1 – Upper Dam - Site visit in December 2017. Note water over spillway.

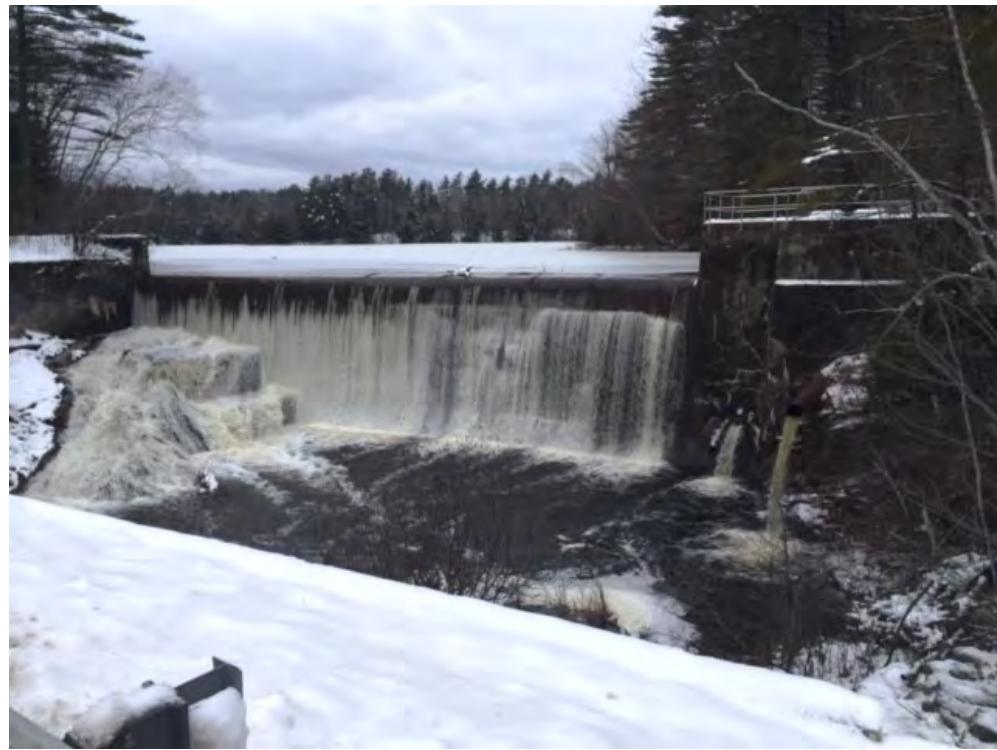
Photo No. 2 – Upper Dam - Site visit in December 2017. Note water over spillway.

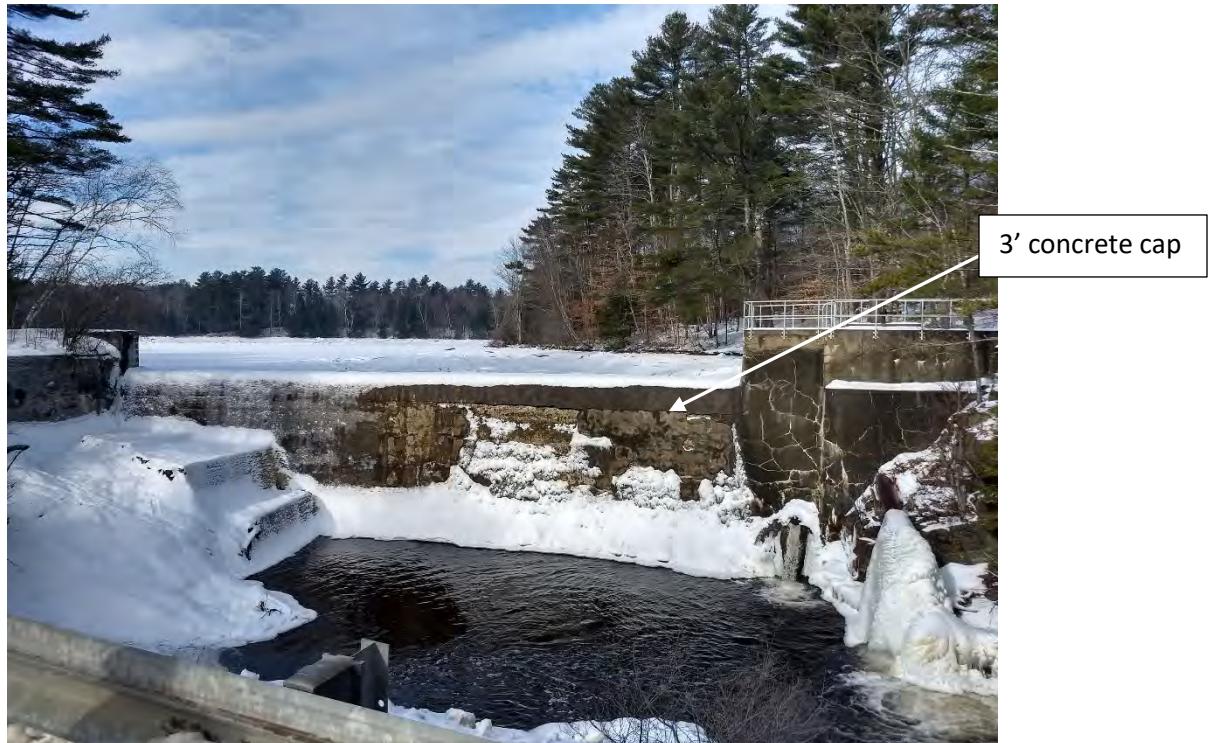
The dam was first observed from the Herrick Road bridge located about 200 ft downstream of the dam. The 18-inch and the upper outlet (higher of the 6-inch or 8-inch outlet pipes) were discharging flow at the time of the visit (Photos 3 and 4). Water was ponded at the downstream toe, so the foundation conditions at the downstream toe were not able to be observed. Bedrock outcroppings were observed on the left downstream side of the dam. Prevalent alligator cracking with some efflorescence was observed on the downstream side of the left abutment.

The horizontal construction joint for the 3-ft concrete cap was observed on the spillway (Photo 3). In the photos taken during a GEI site visit in December 2017, the flow is disturbed at the cap construction joint, indicating either leakage through the joint or an offset in the downstream face (Photos 1 and 2). A large section of the surficial gunite has been eroded off the downstream face of the spillway below the concrete cap, exposing the original concrete beneath (Photo 4). Other areas of the gunite spillway surface have spalled, and there is significant cracking of the gunite.

Photo No. 3 – Upper Dam – Downstream face. Note 18" and 8" outlets flowing.

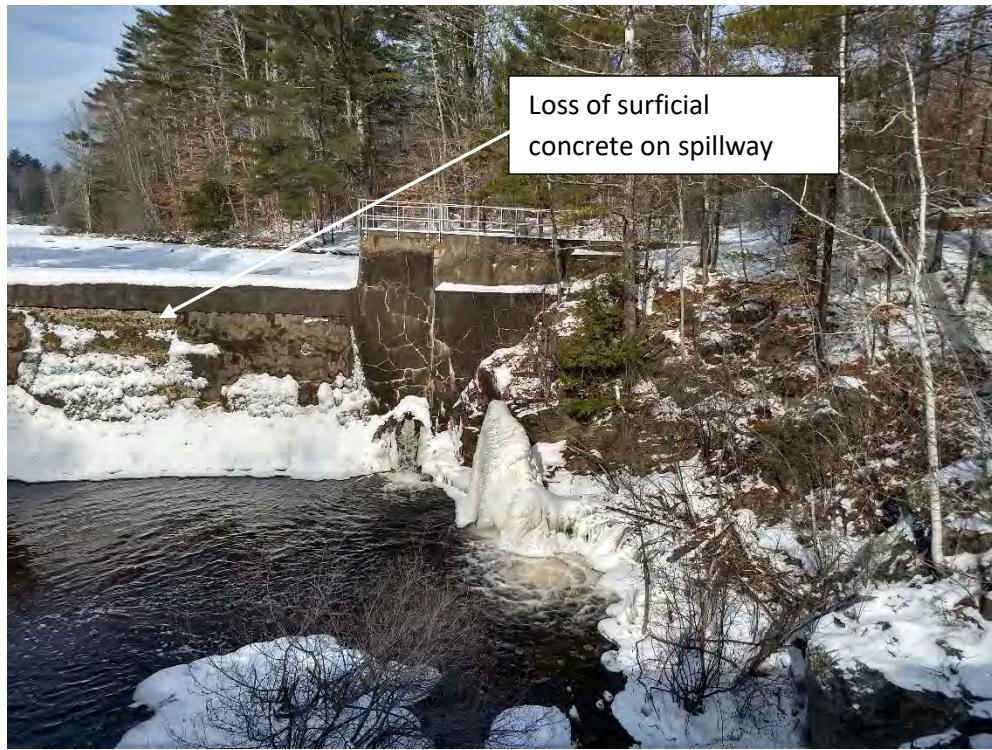
Photo No. 4 – Upper Dam – Downstream side of left abutment and spillway. Note cracks in abutment and loss of surficial concrete on spillway.

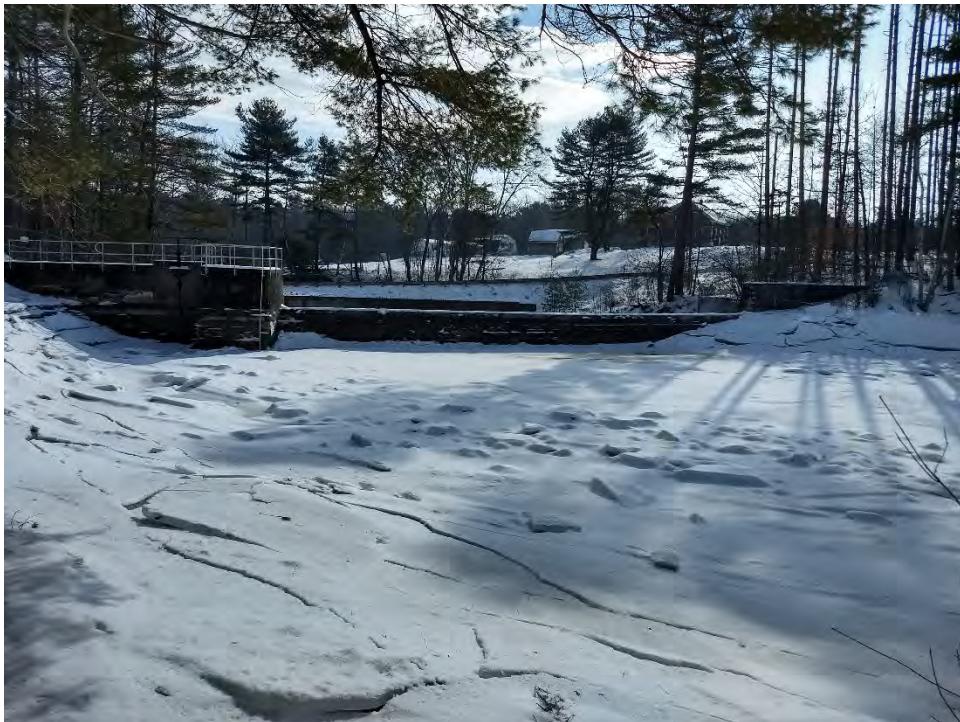
The reservoir was estimated to be approximately 6 ft below the spillway sill (Photo 5). The reservoir was ice-covered, and there was ice against the dam. The upstream left abutment and intake tower had prevalent cracking with efflorescence and spalling/loss of the gunite

Photo No. 5 – Upper Dam – Upstream face. Note reservoir approximately 6' below spillway sill.

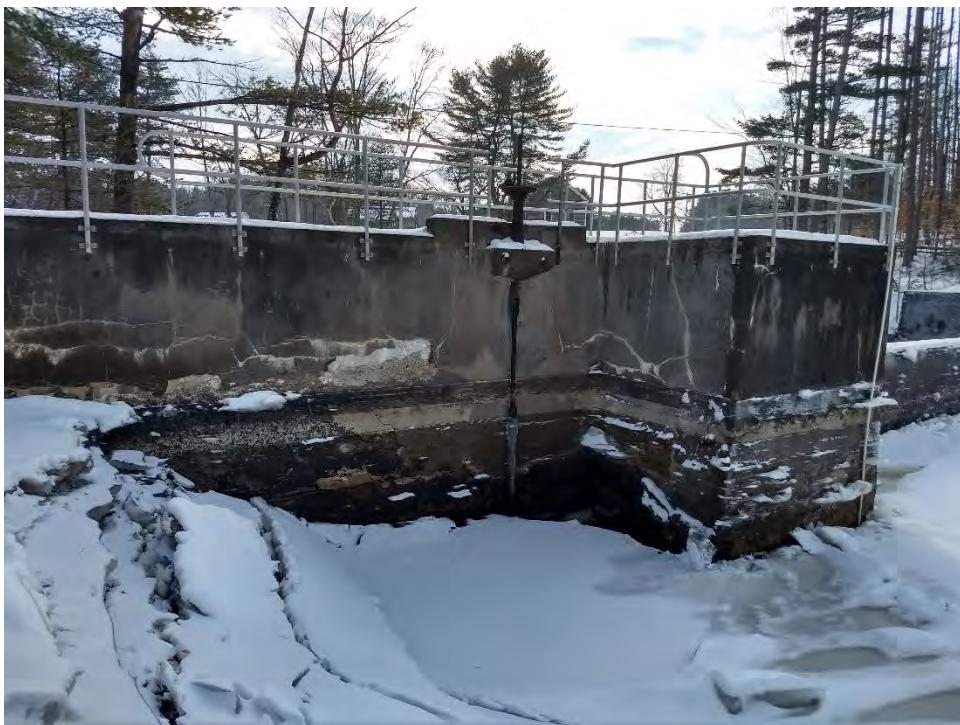
Photo No. 6 – Upper Dam – Upstream side of left abutment. Note 18" gate stem and cracking and spalling concrete.

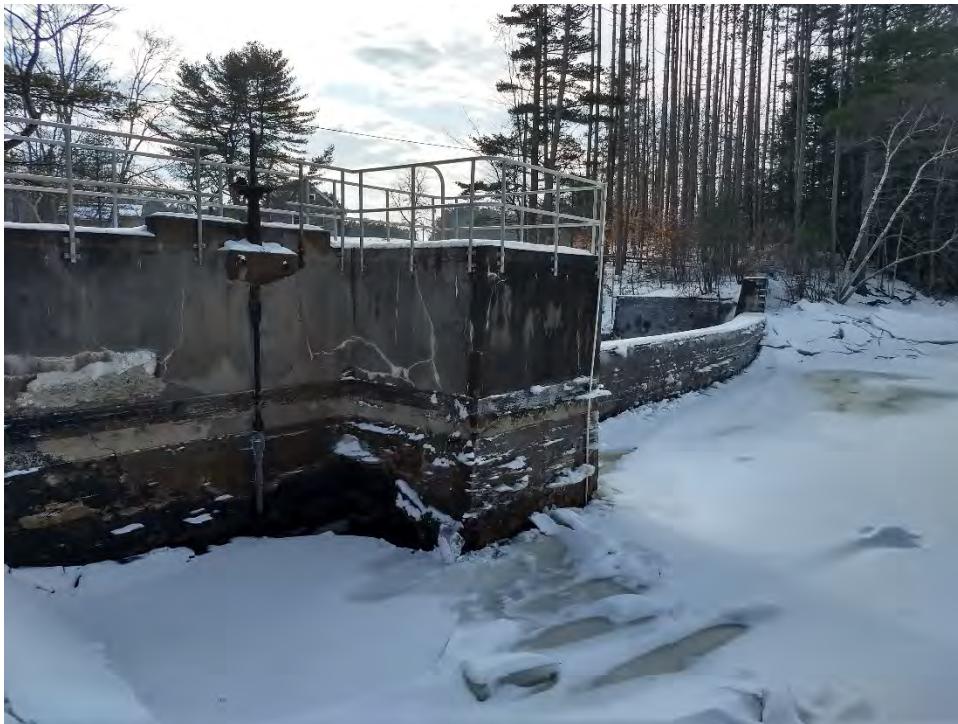
Photo No. 7 – Upper Dam – Upstream side of left abutment and spillway. Note ice against spillway face.

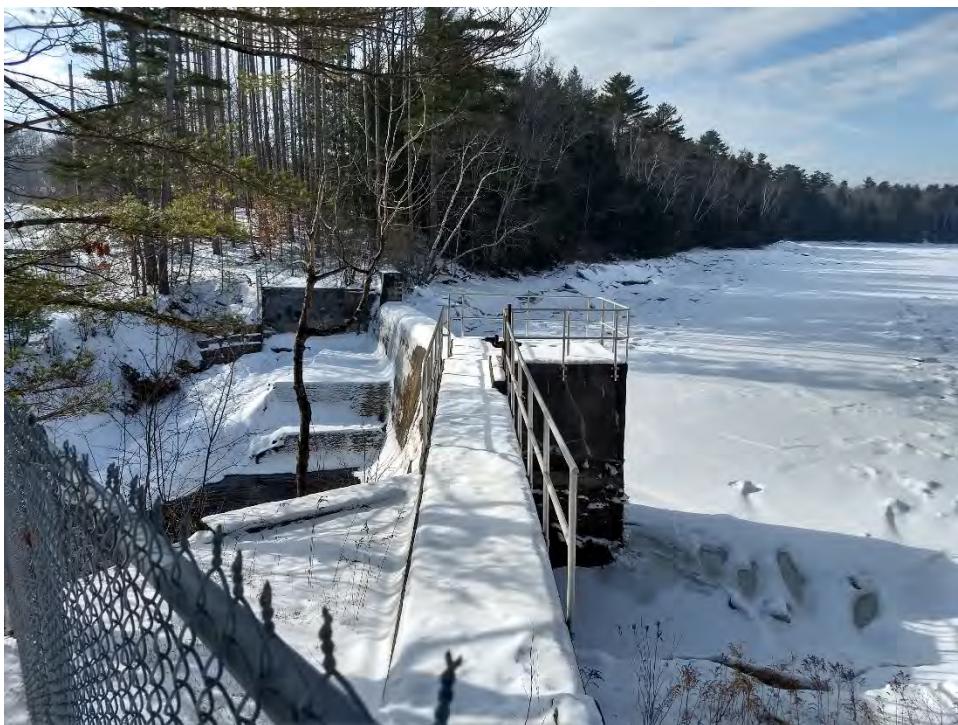
Photo No. 8 – Upper Dam – Dam crest, looking right.

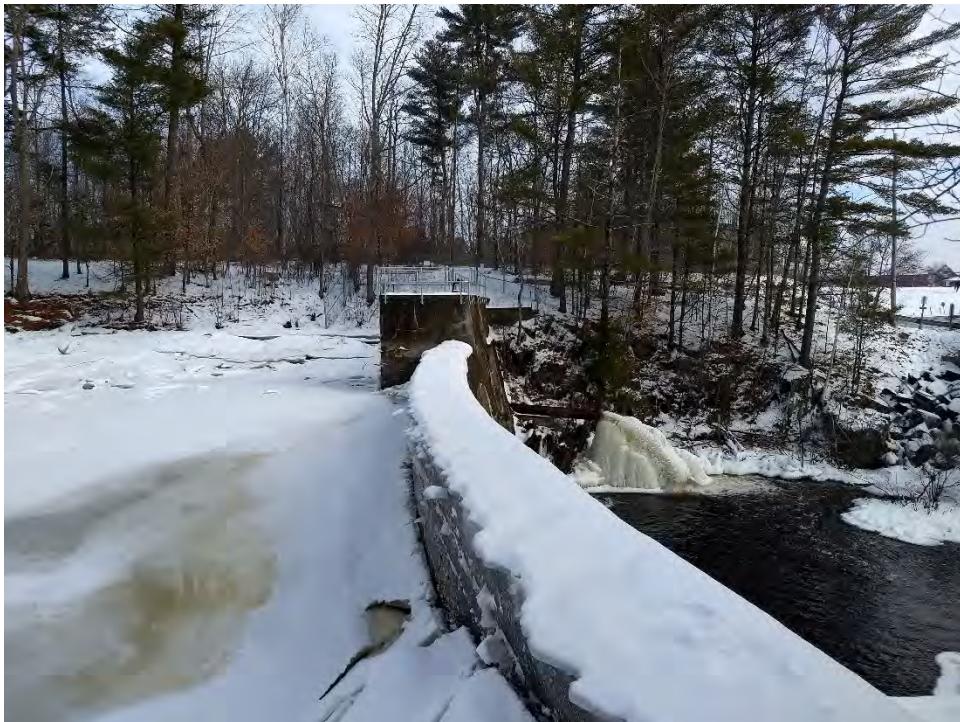
Photo No. 9 – Upper Dam – Spillway sill, looking left.

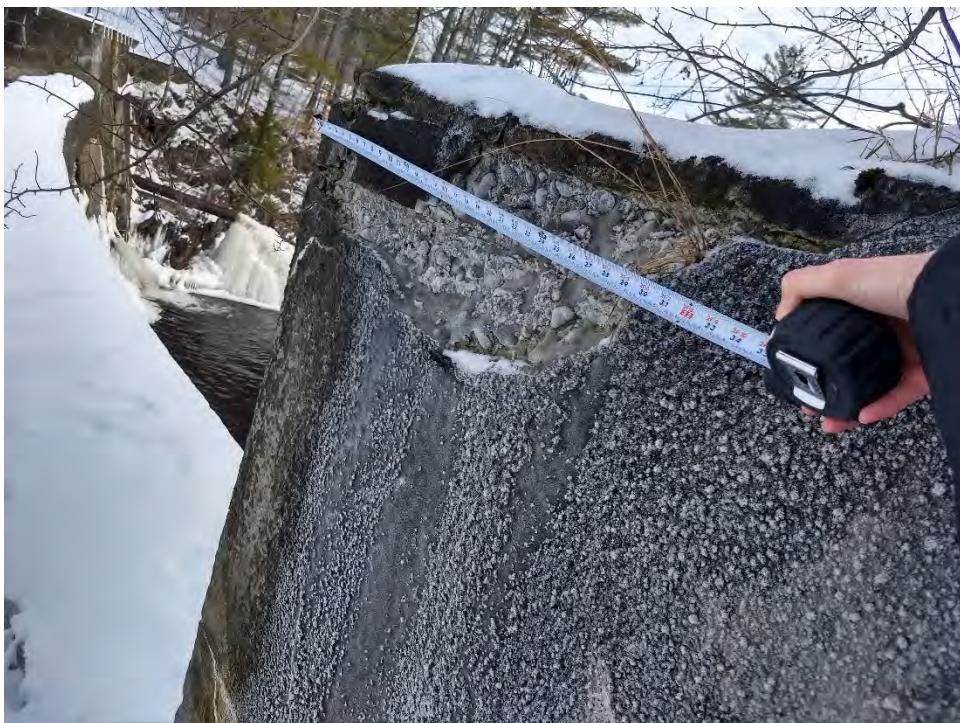
surfacing (Photos 6 and 7). There was no obvious misalignment of the crest (Photos 8 and 9). The upstream right abutment retaining wall was observed to have spalling and cracking in the gunite surface (Photos 10 and 11). There also appeared to be a failing gunite repair that was separating about $\frac{1}{2}$ -inch off the face of the wall (Photo 11).

Photo No. 10 – Upper Dam – Upstream side of right abutment retaining wall. Note spalling concrete.

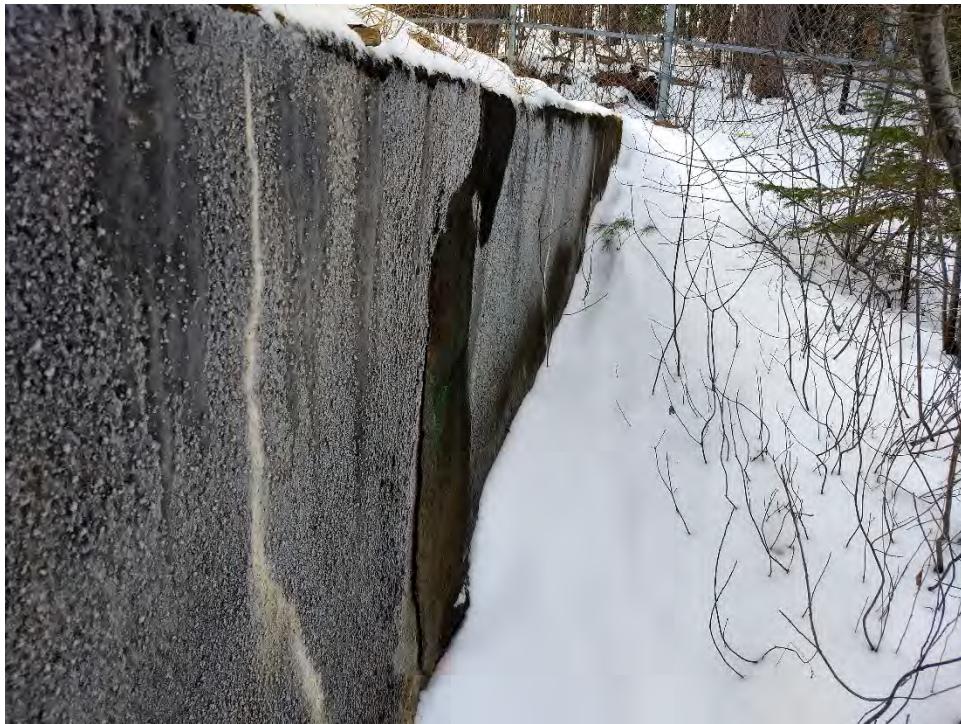
Photo No. 11 – Upper Dam – Right abutment retaining wall, looking right. Note cracking and failing concrete repairs.

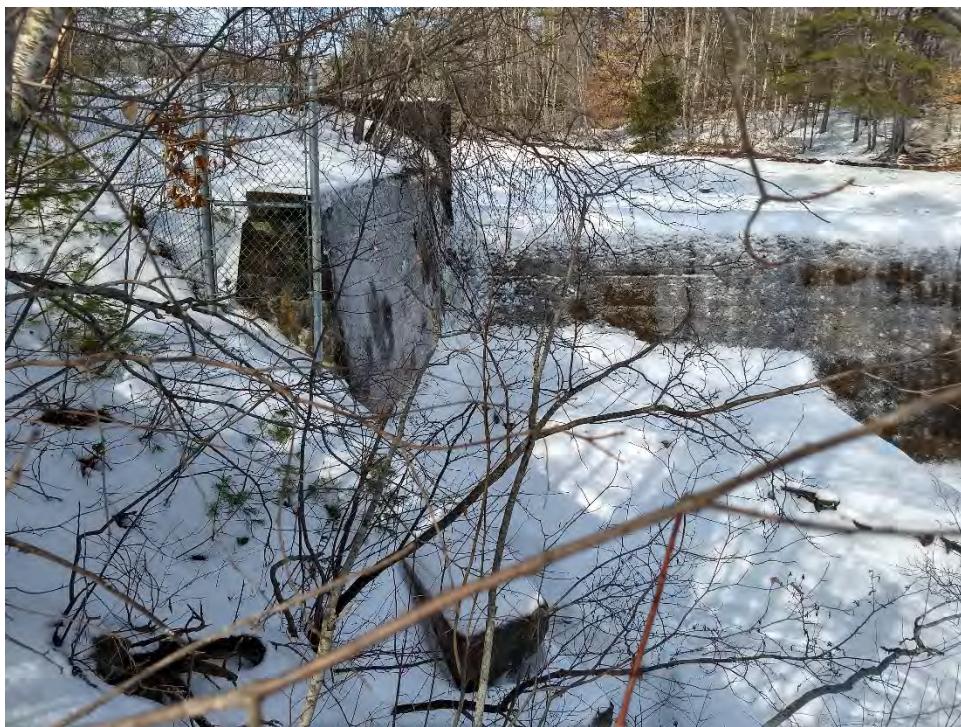
The stepped apron at the right downstream side of the spillway was covered in snow and not able to be observed with any detail (Photo 13). There was some yellowish discoloration of the ice along the contact between the spillway and lower two apron steps. Ground conditions at the right downstream embankment were not able to be observed due to the snow cover. The downstream training walls on the right side were observed from a distance but difficult to see due to the ground conditions and being unable to approach the walls (Photos 12 and 13).

Photo No. 12 – Upper Dam – Right downstream side of spillway and downstream training wall.

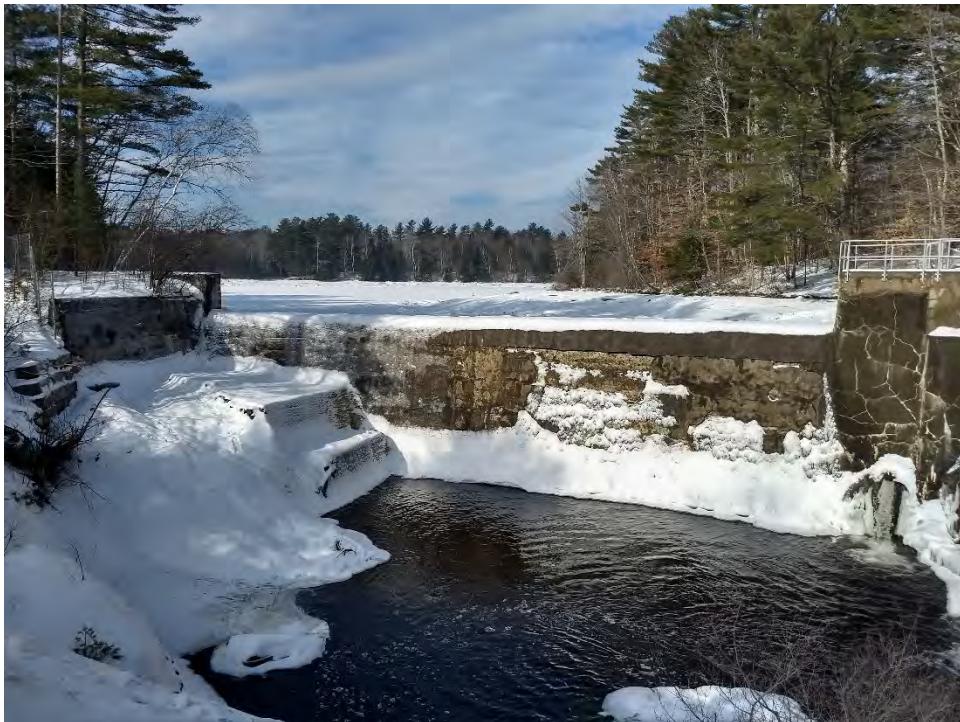
Photo No. 13 – Upper Dam – Downstream side of dam. Note right abutment training wall and concrete apron.

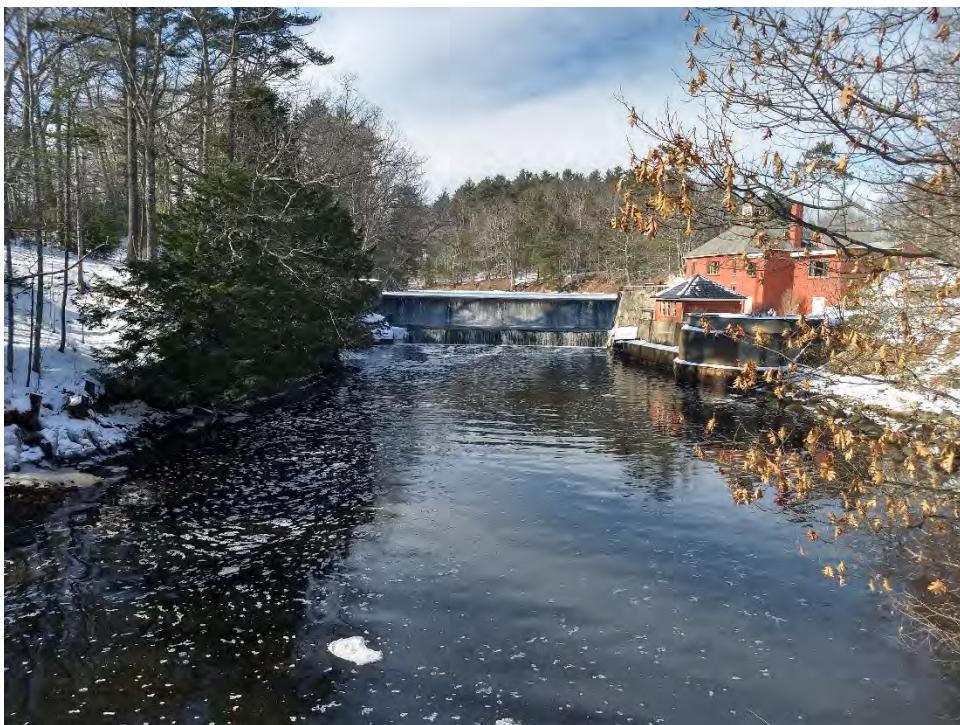
The Lower Dam was spilling a couple of inches over the spillway on the day of the site visit (Photos 14 and 15). The reservoir was ice covered to the top of the spillway (Photos 16 and 18). The intake that is understood to be inoperable was observed on the upstream side of the left abutment (Photo 17). As observed from the left abutment, the right abutment wall facing the spillway had cracking with efflorescence about halfway up the wall (Photos 15 and 18). The efflorescence is typically indicative of seepage having occurred through the cracks. Some vegetation was observed at the downstream toe of the right abutment wall where the wall turns 90 degrees towards the right abutment before turning back downstream. Weep holes were observed in the right downstream training wall located a couple of feet from the top of the wall (Photo 18).

Photo No. 14 – Lower Dam – Downstream side of spillway, looking upstream.

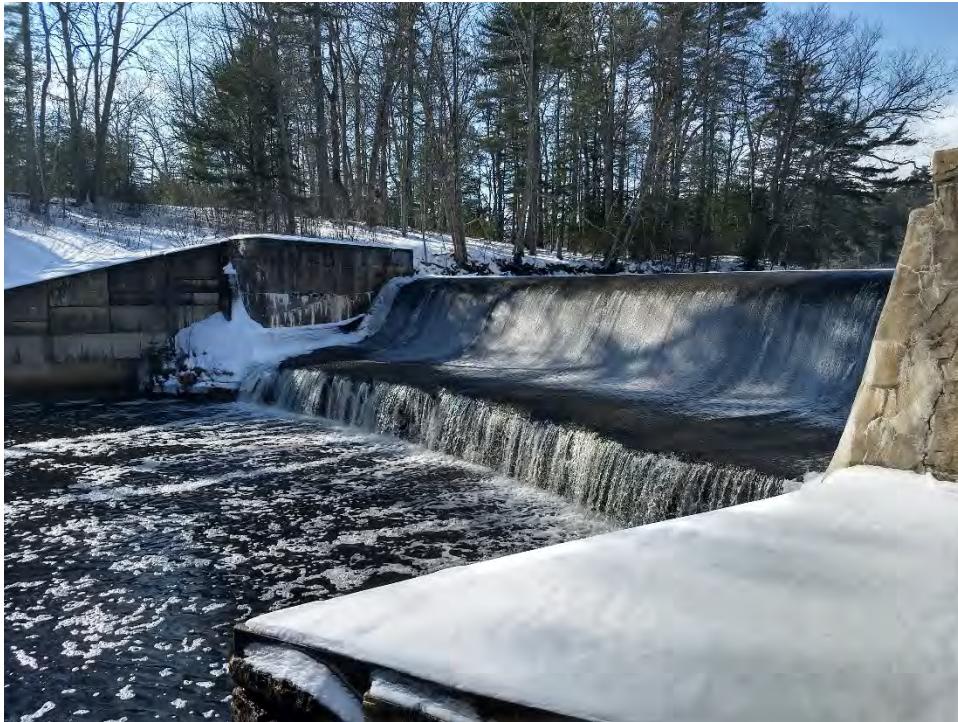
Photo No. 15 – Lower Dam – Downstream side of spillway. Note spilling by a couple of inches, vegetation on right downstream toe.

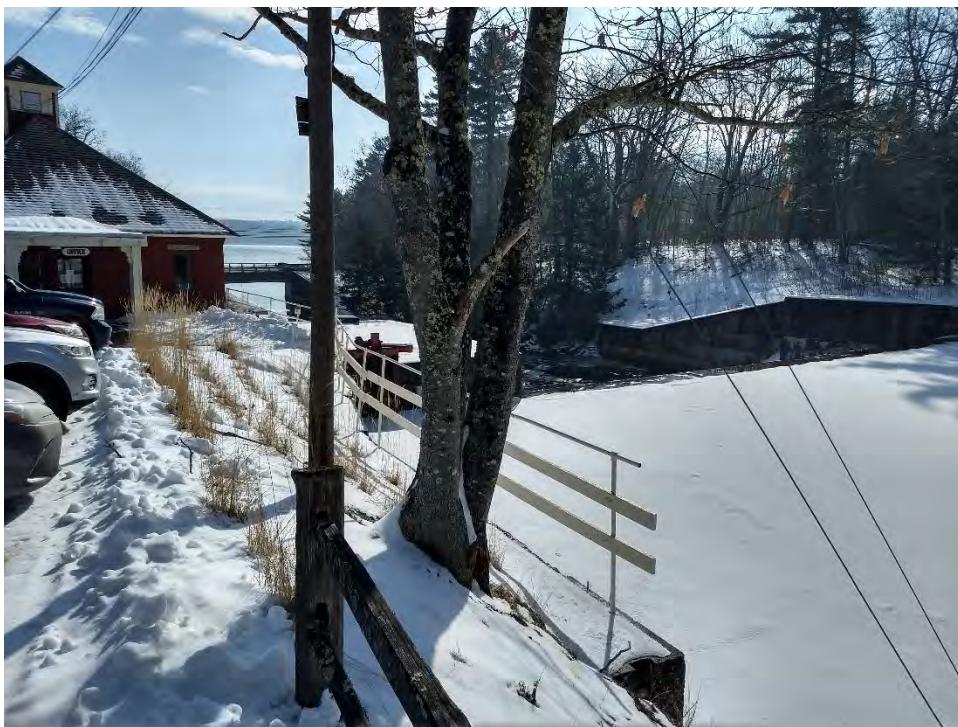
Photo No. 16 – Lower Dam – Upstream side of Left Abutment, looking downstream.

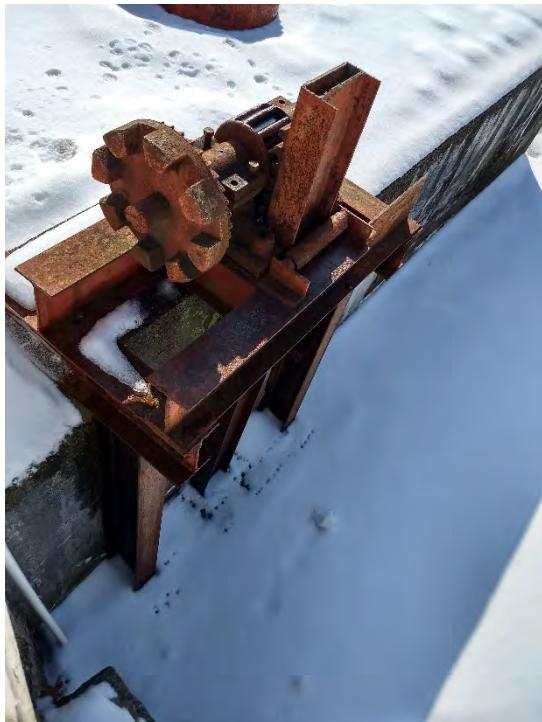
Photo No. 17 – Lower Dam – Intake on left abutment.

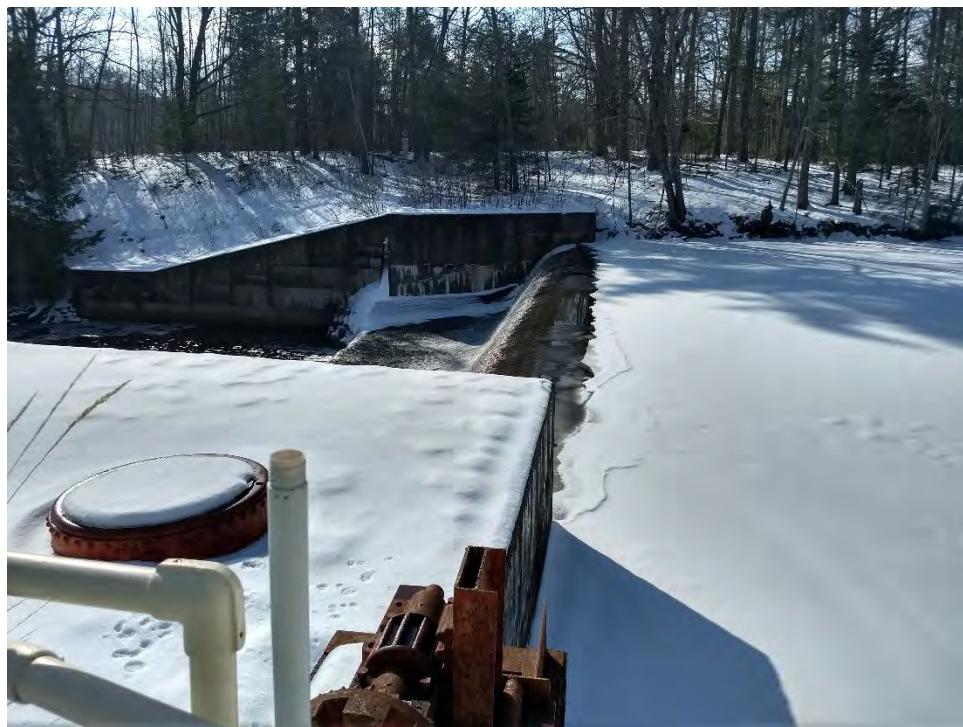
Photo No. 18 – Lower Dam – looking right. Note cracking with efflorescence on right abutment.

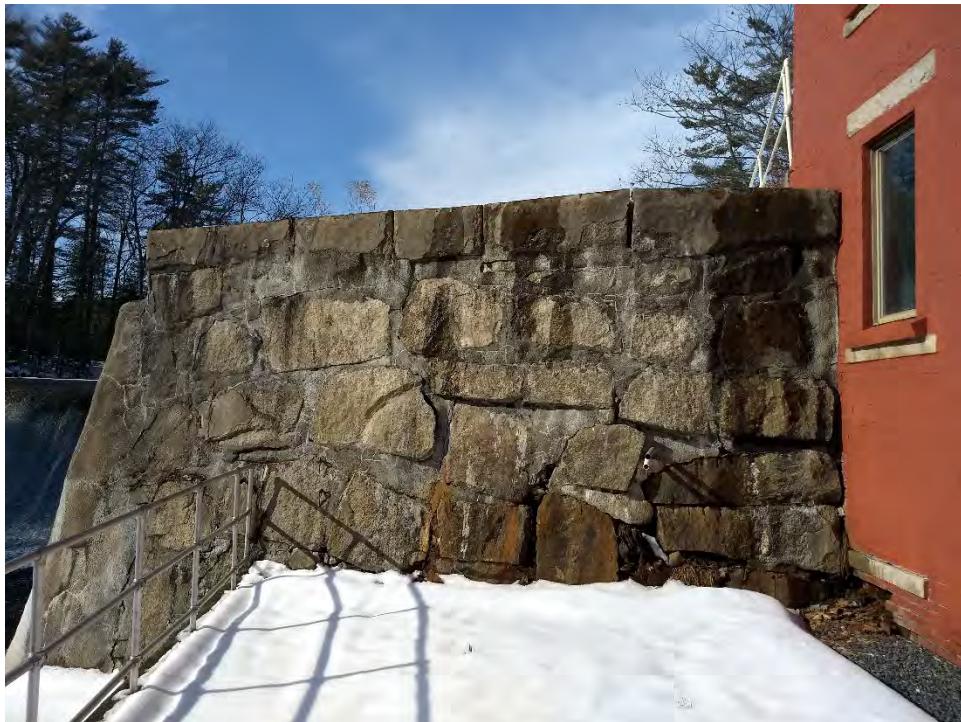
Photo No. 19 – Lower Dam – Downstream side of left abutment.

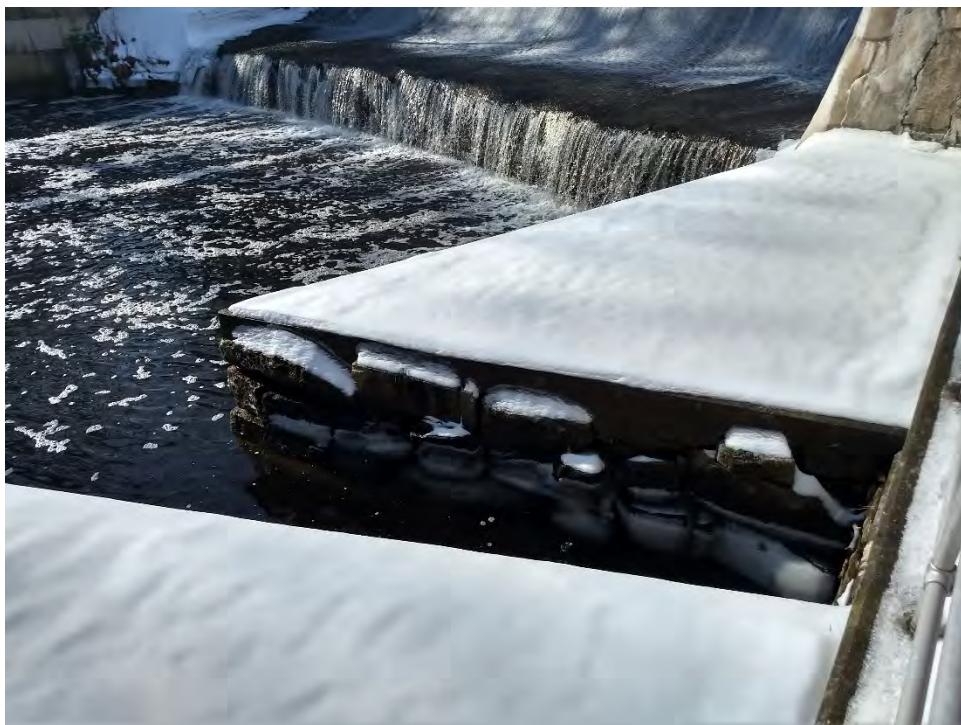
Photo No. 20 – Lower Dam – Downstream masonry training wall on left side.

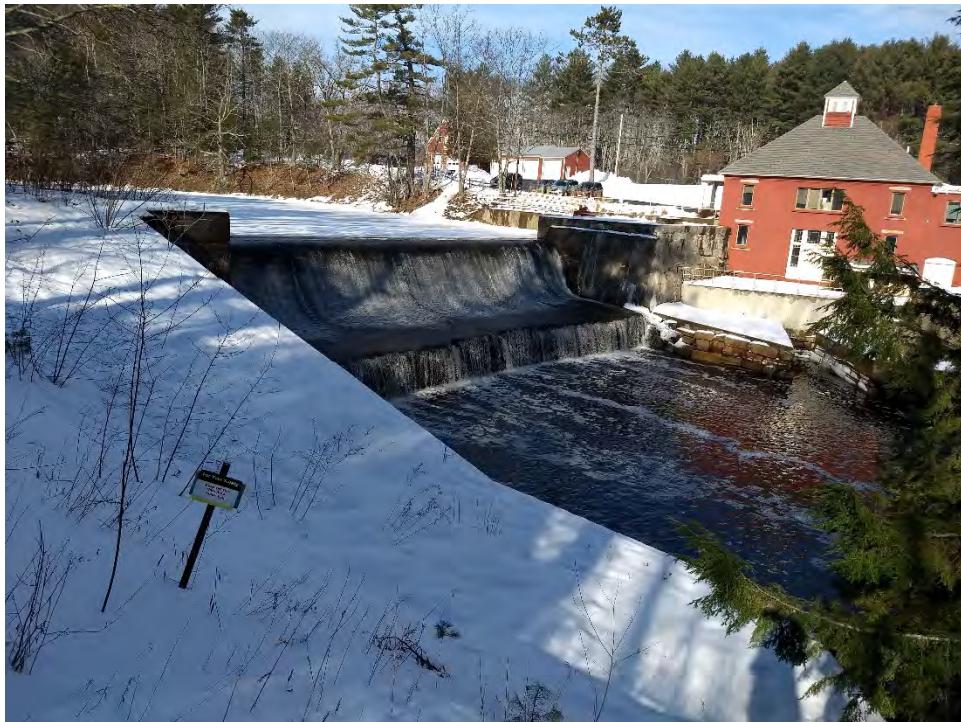
Photo No. 21 – Lower Dam – looking towards left abutment. Note cracking with efflorescence on left abutment.

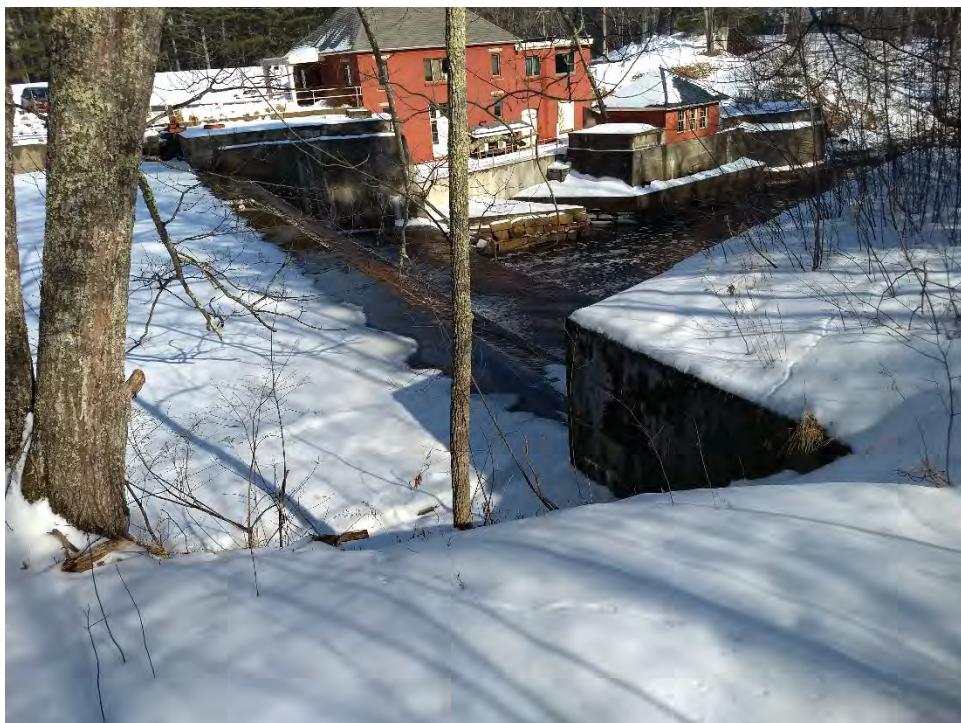
Photo No. 22 – Lower Dam – Upstream side of right abutment.

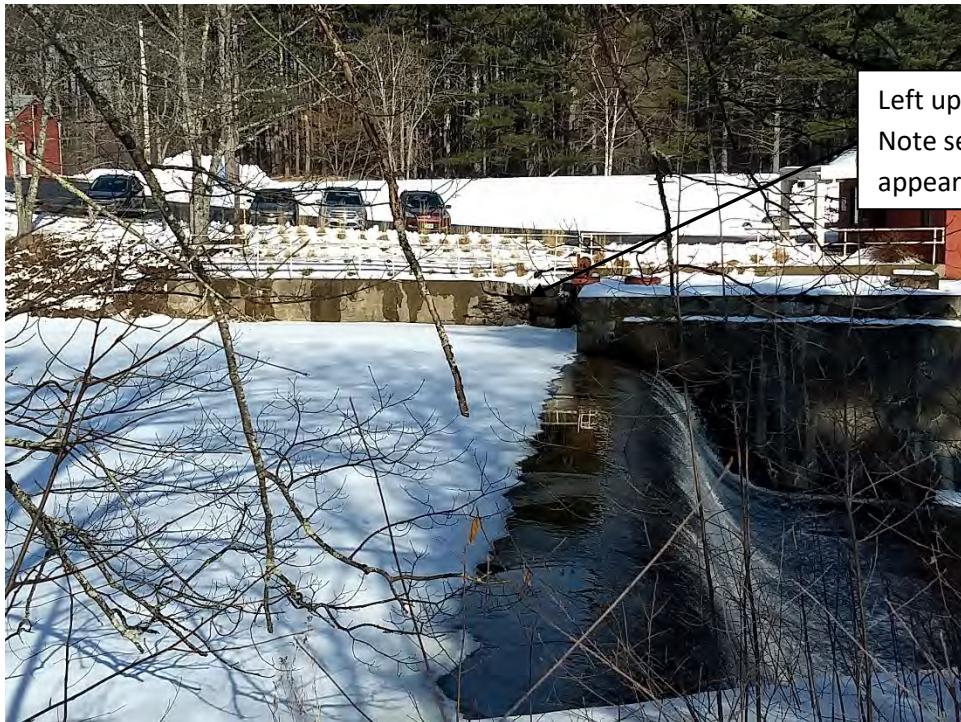
Photo No. 23 – Lower Dam – Upstream left abutment training wall. Note section where concrete facing appears to have failed.
