**Assessment of the Nordic Aquafarms Permit to Satisfy
Clean Water Act Requirements**

Testimony to the Maine DEP Water Supply and Dam Evaluation

Proposed Nordic Aquafarms, Belfast Maine

December 13, 2019
Project 1900162

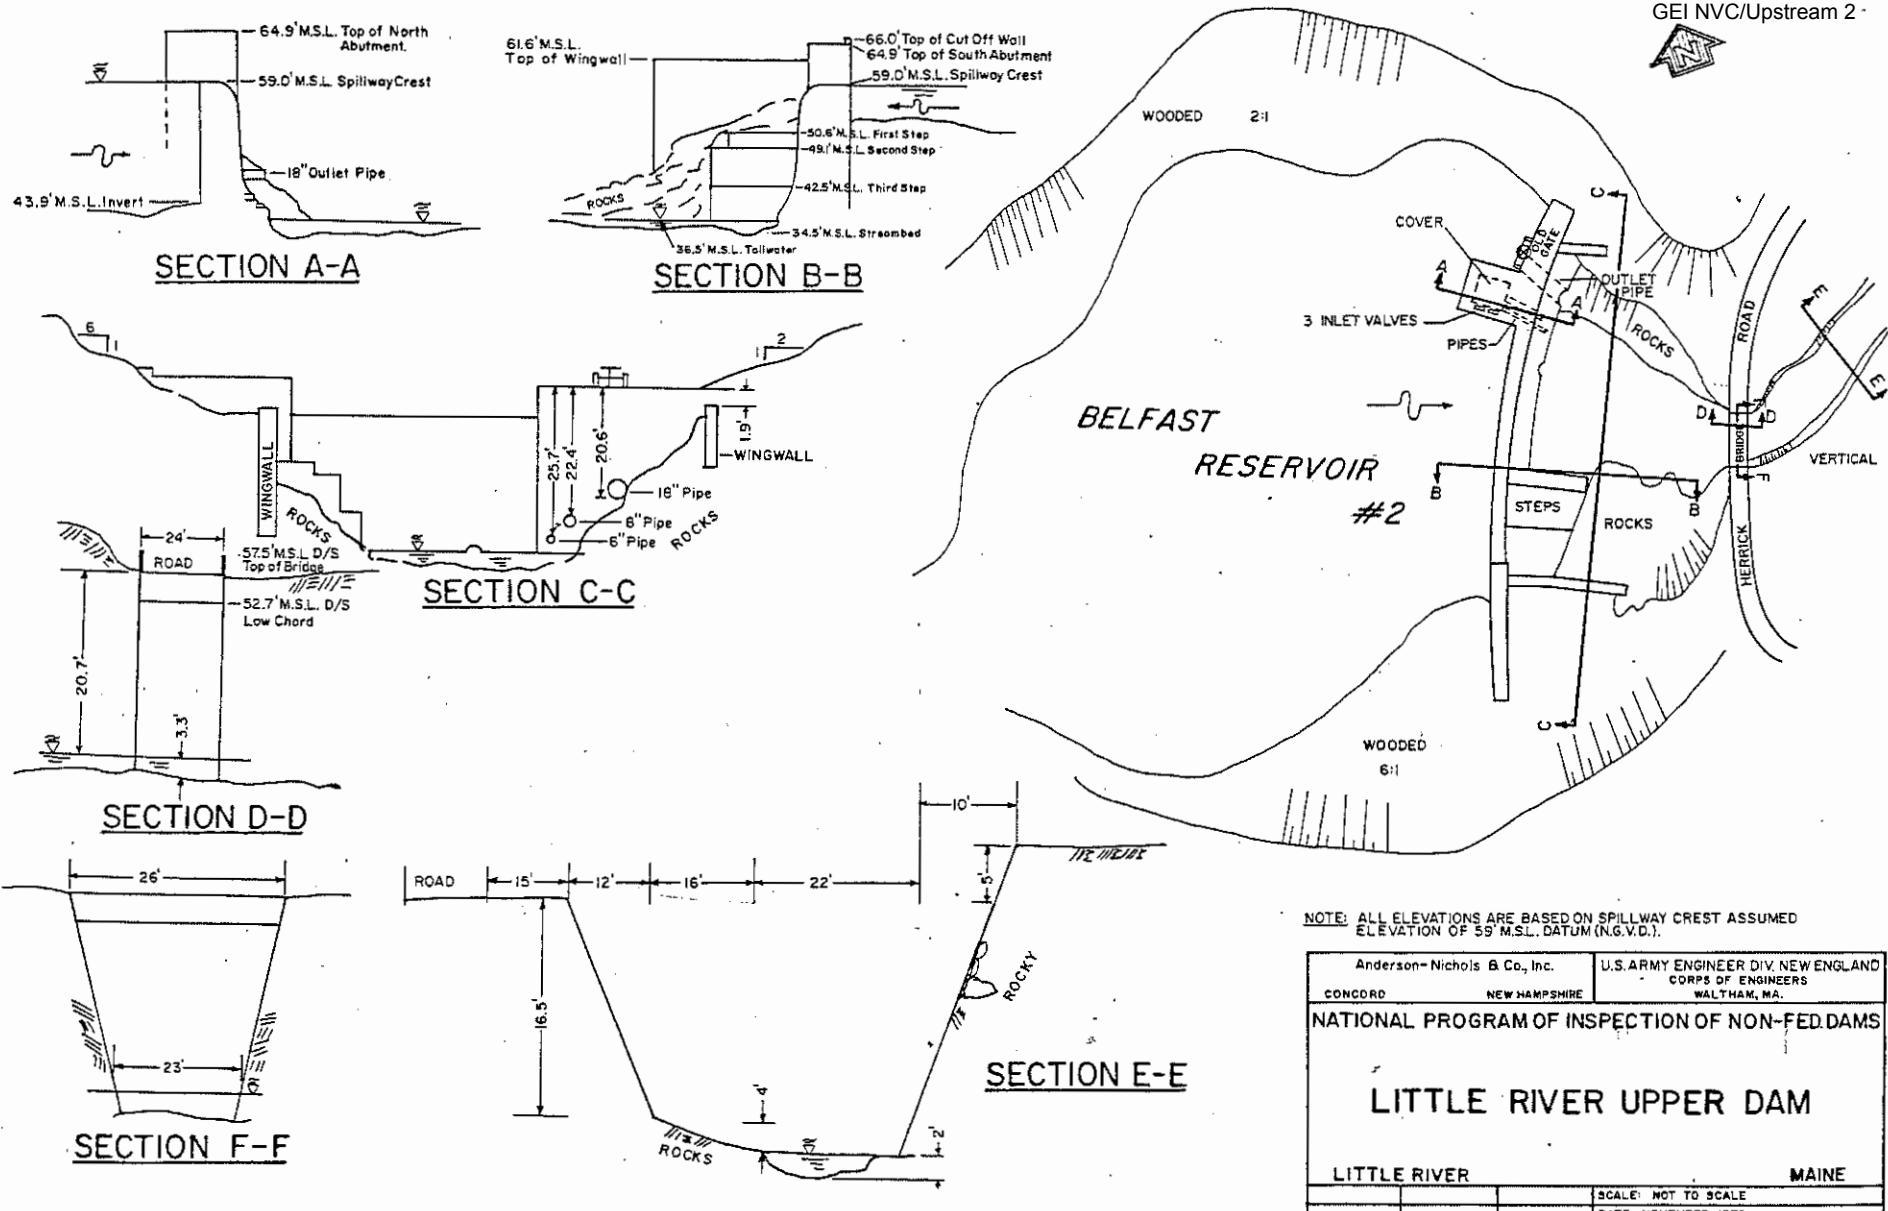
Fig. 2
Source: USACE 1979b

There are bedrock outcroppings downstream of the dam, and the dam is at least partially founded on rock. On the right side of the dam, there is a concrete training wall that extends downstream with earth fill behind the wall. There is concrete stair apron on the right downstream side of the spillway, likely to protect the underlying rock from erosion (USACE 1979b). The Upper Dam is shown in Fig. 2 of this report.
